To repair the damaged straps on your SmartScan case, please follow the instructions as shown below:

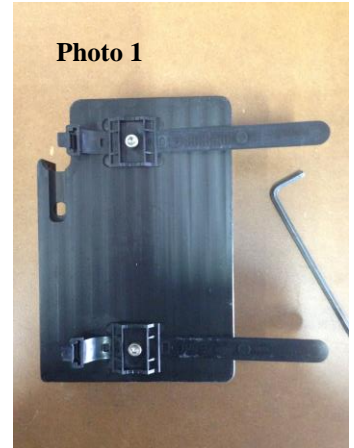
- Place the case on a bench and remove the damaged straps with an allen wrench
 - See photo #1
- Layout the parts and please notice that each of the two clips in the repair kit fit on the back of the SmartScan and are attached with the two original fasteners
 - See photo #2 & #3
- Use the allen wrench (not included) to tighten the new clips into the case as shown
- Two ty-wraps are fed through each of the two clips in opposite directions
- Please notice that the two straps are inserted with the flat side up
 - See photo #3 & #4

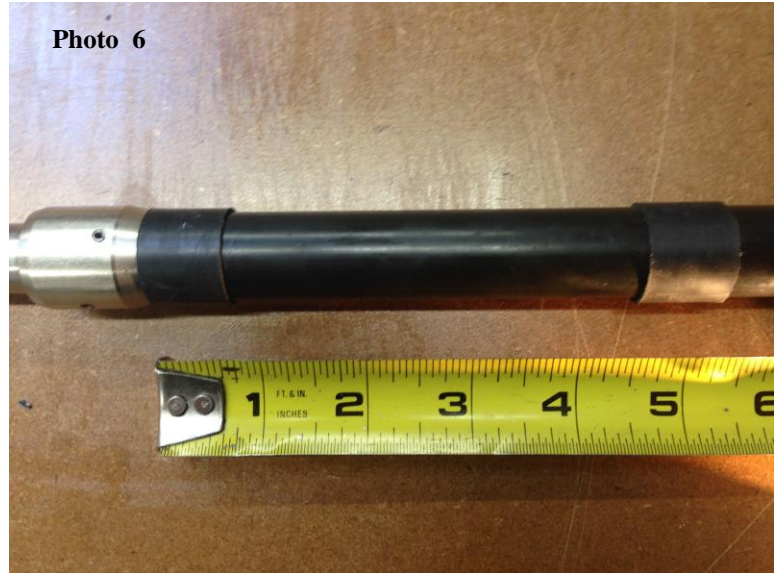
- With SmartScan Case prepared, as shown above, the customer must now prepare the basic chimney rod. In these photos, the Lindemann ButtonLok rod is shown.

- The Smartscan kit comes with four pieces of an adhesive-backed neoprene material that the customer is required to wrap around the rod prior to attaching the SmartScan box. Only two neoprene bands are required for a SmartScan, but two spares have been included.
- As shown in photo #6, the spacing of the bands is about 4 ½ " from top to top or center to center. This spacing will allow both straps through each clip to wrap around and secure the SmartScan case to the chimney rod.

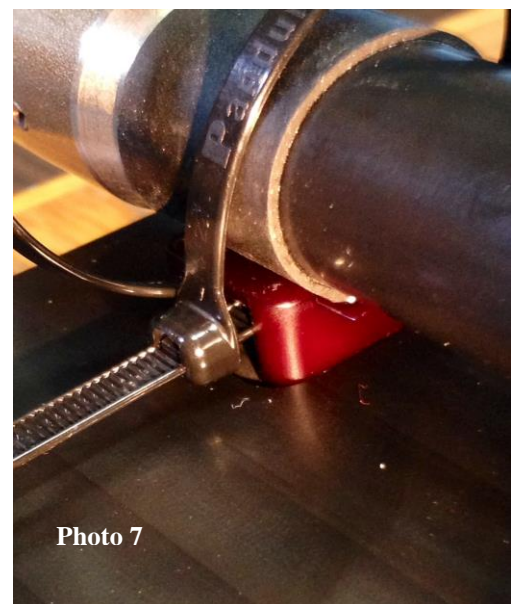
- Once the Chimney rod (with the adhesive-backed neoprene bands in place) is laid over the retaining clips, wrap the ty-wraps loosely around and insert the tapered end into the flat side of the retainer end.
- For optimal results, make sure that the flat side of the retainer is against the side of the clip on the
 - See photo #7

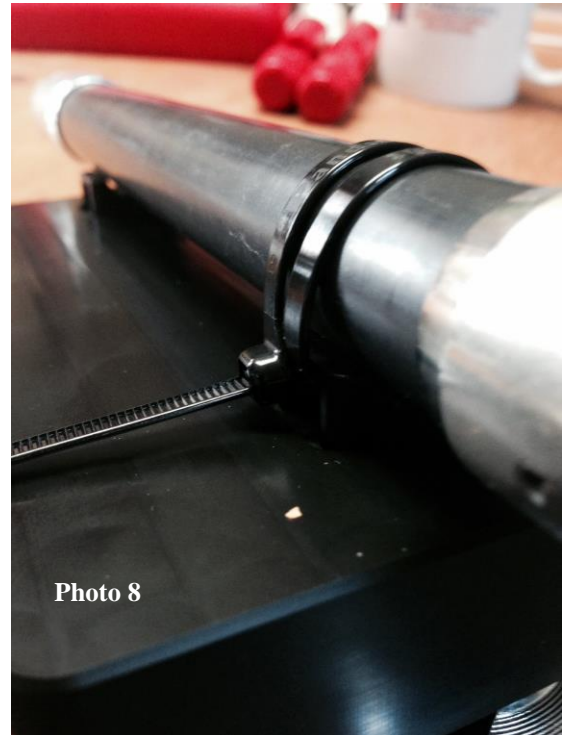
- Once the straps are in place, they can be tightened against the Neoprene band to insure that the SmartScan case does not rotate on the Chimney rod.
 - The tighter, the better
 - See photo #8

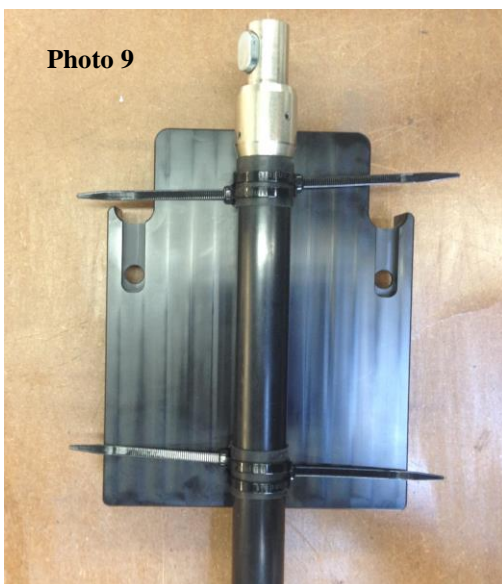
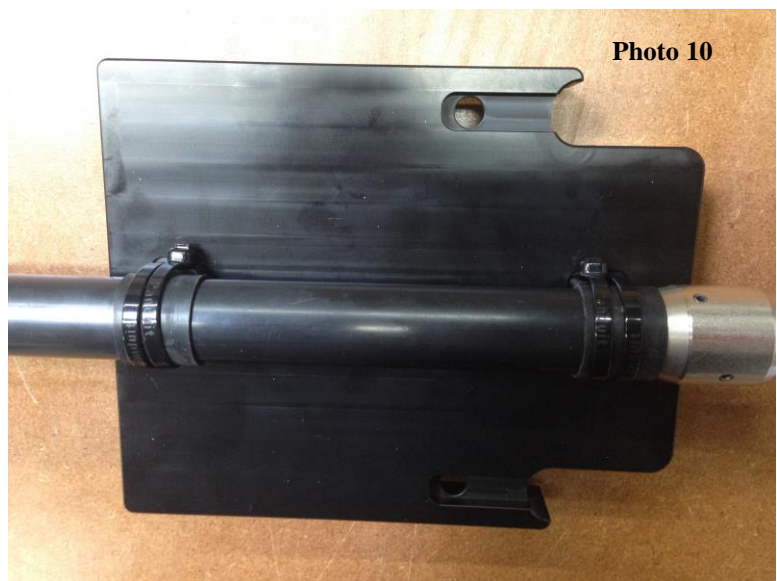
- The loose ends can then be trimmed off and the assembly is complete
 - See photos #9, #10
